CEEDO-TR-77-21

**MEMBRANE ENCAPSULATED SOIL LAYER
(MESL) FOR CONTINGENCY AIRFIELDS**

U. S. ARMY ENGINEER WATERWAYS EXPERIMENT STATION
SOILS AND PAVEMENTS LABORATORY
P. O. BOX 631 VICKSBURG, MISSISSIPPI 39180

APRIL 1977

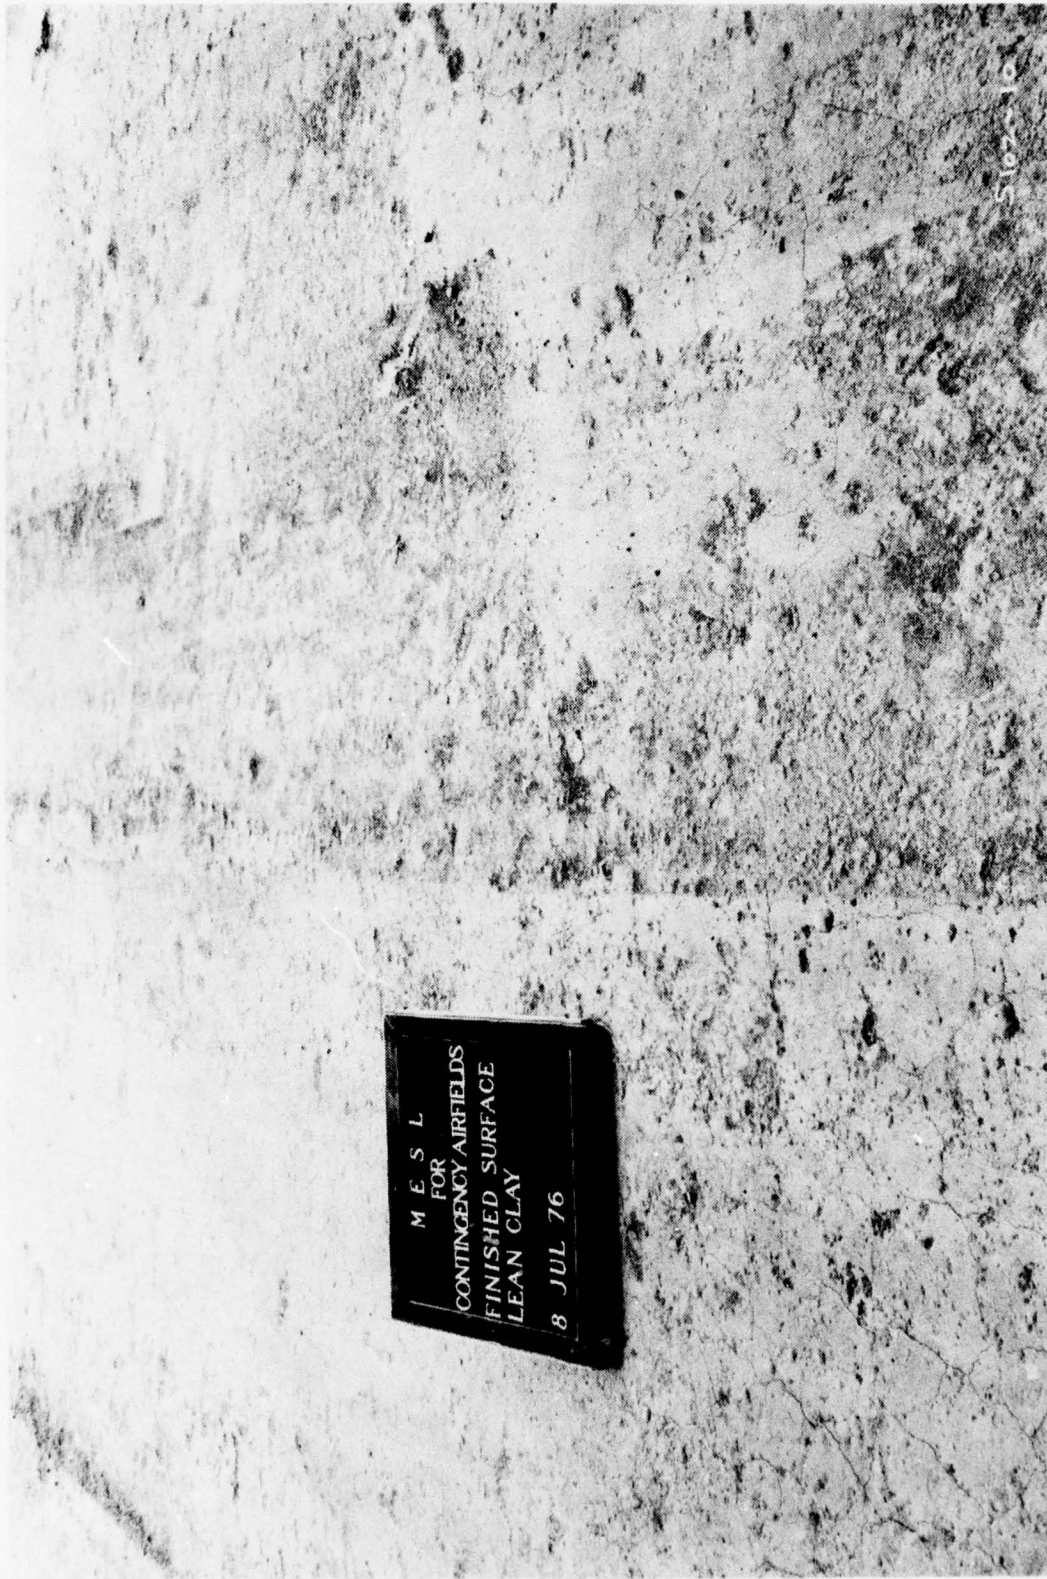
Figure 15. Cracks in Surface of Finished Lean Clay

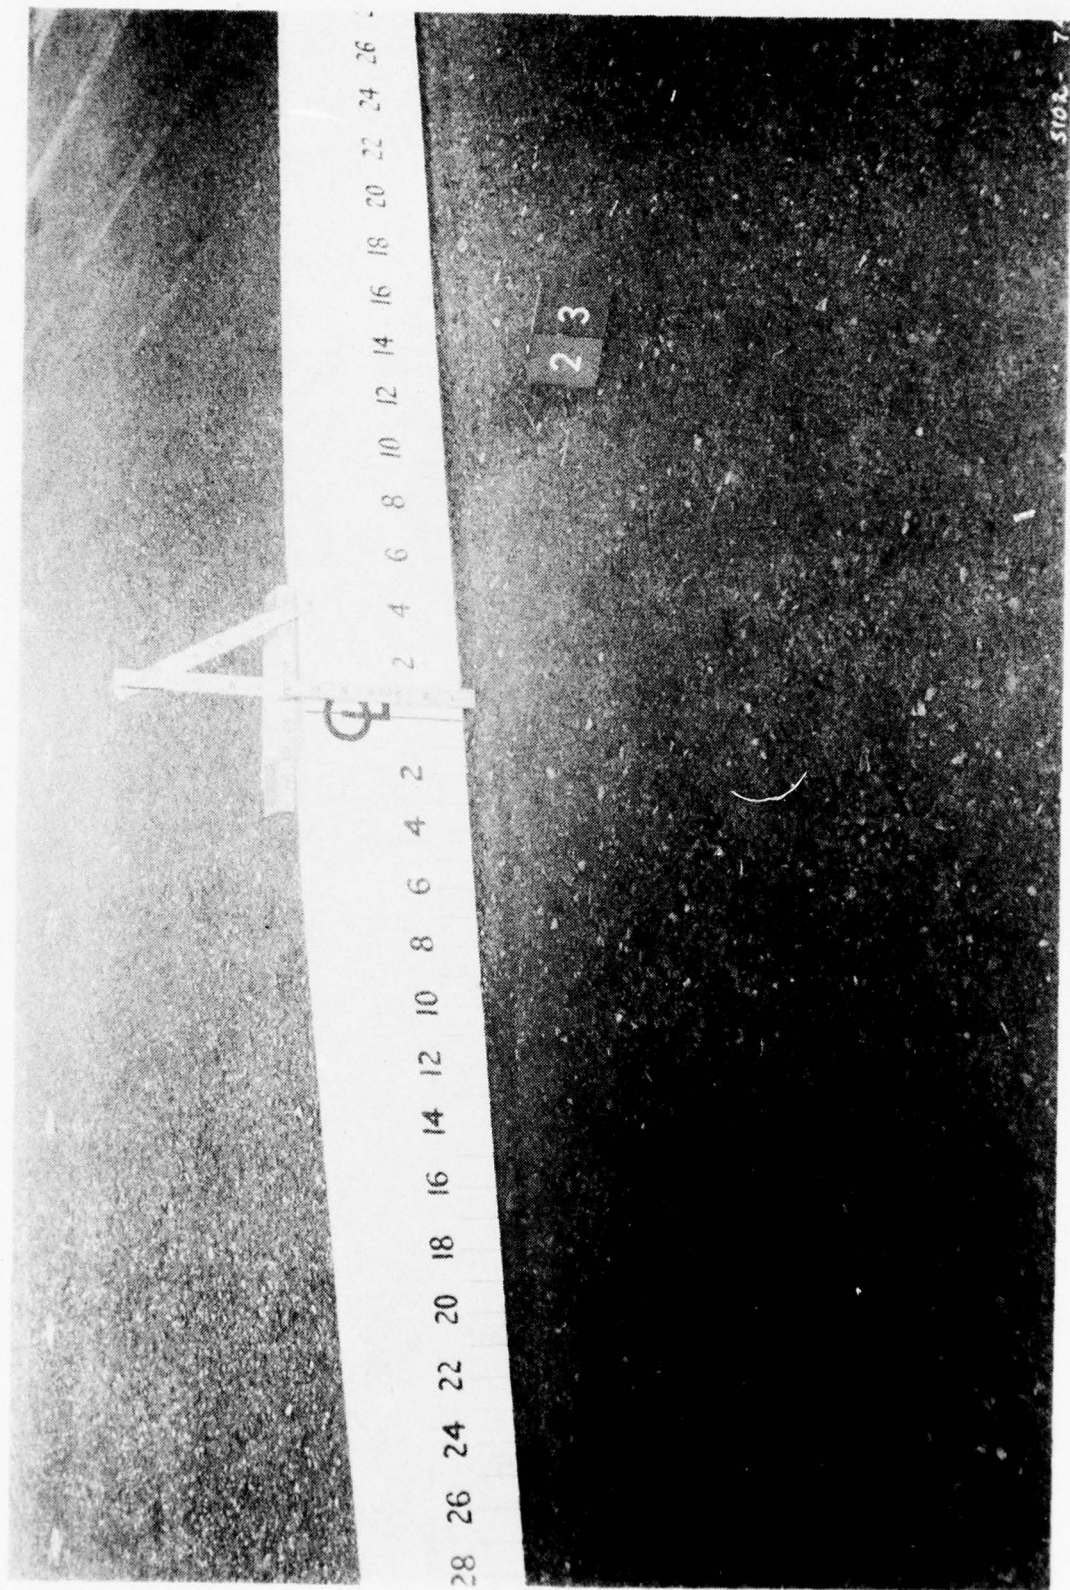
Figure 29 shows item 1 prior to traffic. Typical cross sections taken at 0, 10, 200, and 400 coverages are shown in Figure 27. No cracking was noted in the item up to 200 coverages. After 200 coverages, water was applied, and the pavement kept wet during the second 200 coverages. Traffic was terminated after a total of 400 coverages without failure of the item. At the end of traffic, a few minor hairline cracks were noted in the surface of the pavement, but they did not extend through the asphaltic concrete. Figure 30 shows the overall view of item 1 at termination of traffic. Approximately 0.7 inches of deformation was measured at the center of the traffic lane at termination of traffic (Figure 31).

Figure 31. Deformation in Traffic Lane, Item 1, 400 Coverages

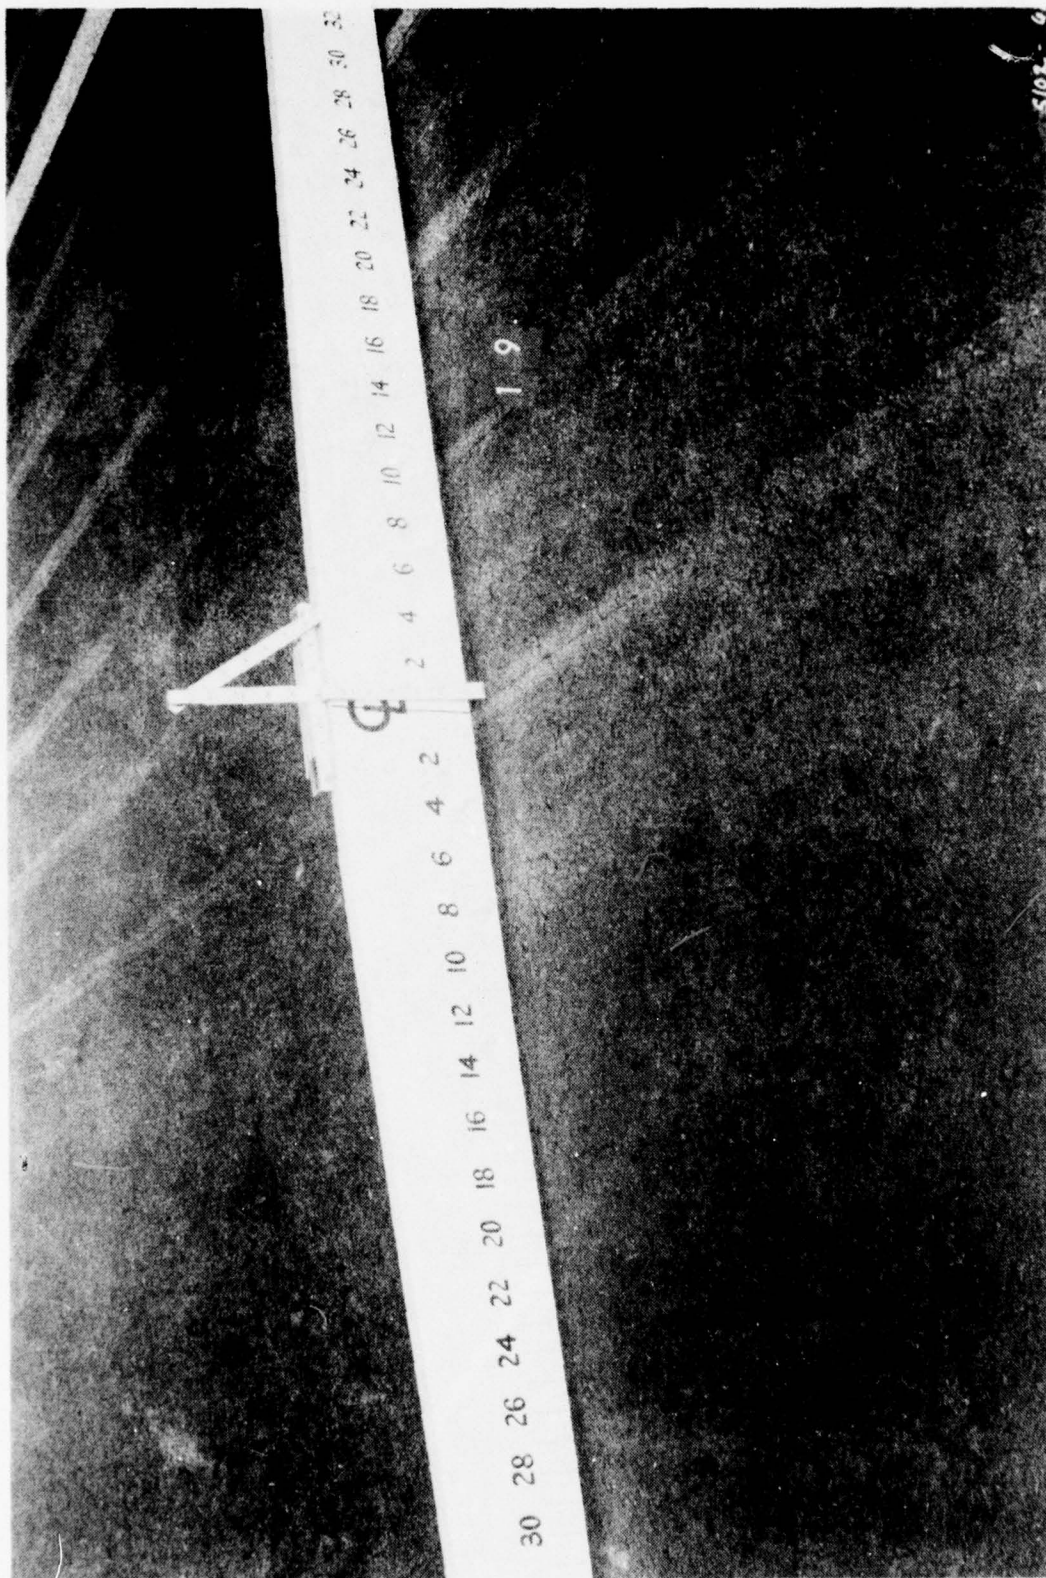
Figure 32 shows item 2 prior to traffic. Typical cross sections taken at 0, 10, 200, and 400 coverages are shown in Figure 27. At 40 coverages small hairline cracks were noted in the surface of the asphaltic concrete. At 200 coverages these cracks were more pronounced but did not extend through the asphaltic concrete. Figure 33 shows the cracks at 200 coverages and deformation of approximately 0.75 inches at the centerline of the traffic lane. After 200 coverages water was applied and the pavement kept wet during traffic for the next 200 coverages. During the last 200 coverages, cracks progressed through the asphaltic concrete and in isolated areas through the top membrane of the MESL; therefore, the item was considered failed at 400 coverages. Figure 34 shows an overall view at 400 coverages, and Figure 35 shows deformation of approximately 1 inch that had occurred at the centerline of the traffic lane.

Figure 33. Deformation in Traffic Lane, Item 2, After 200 Coverages

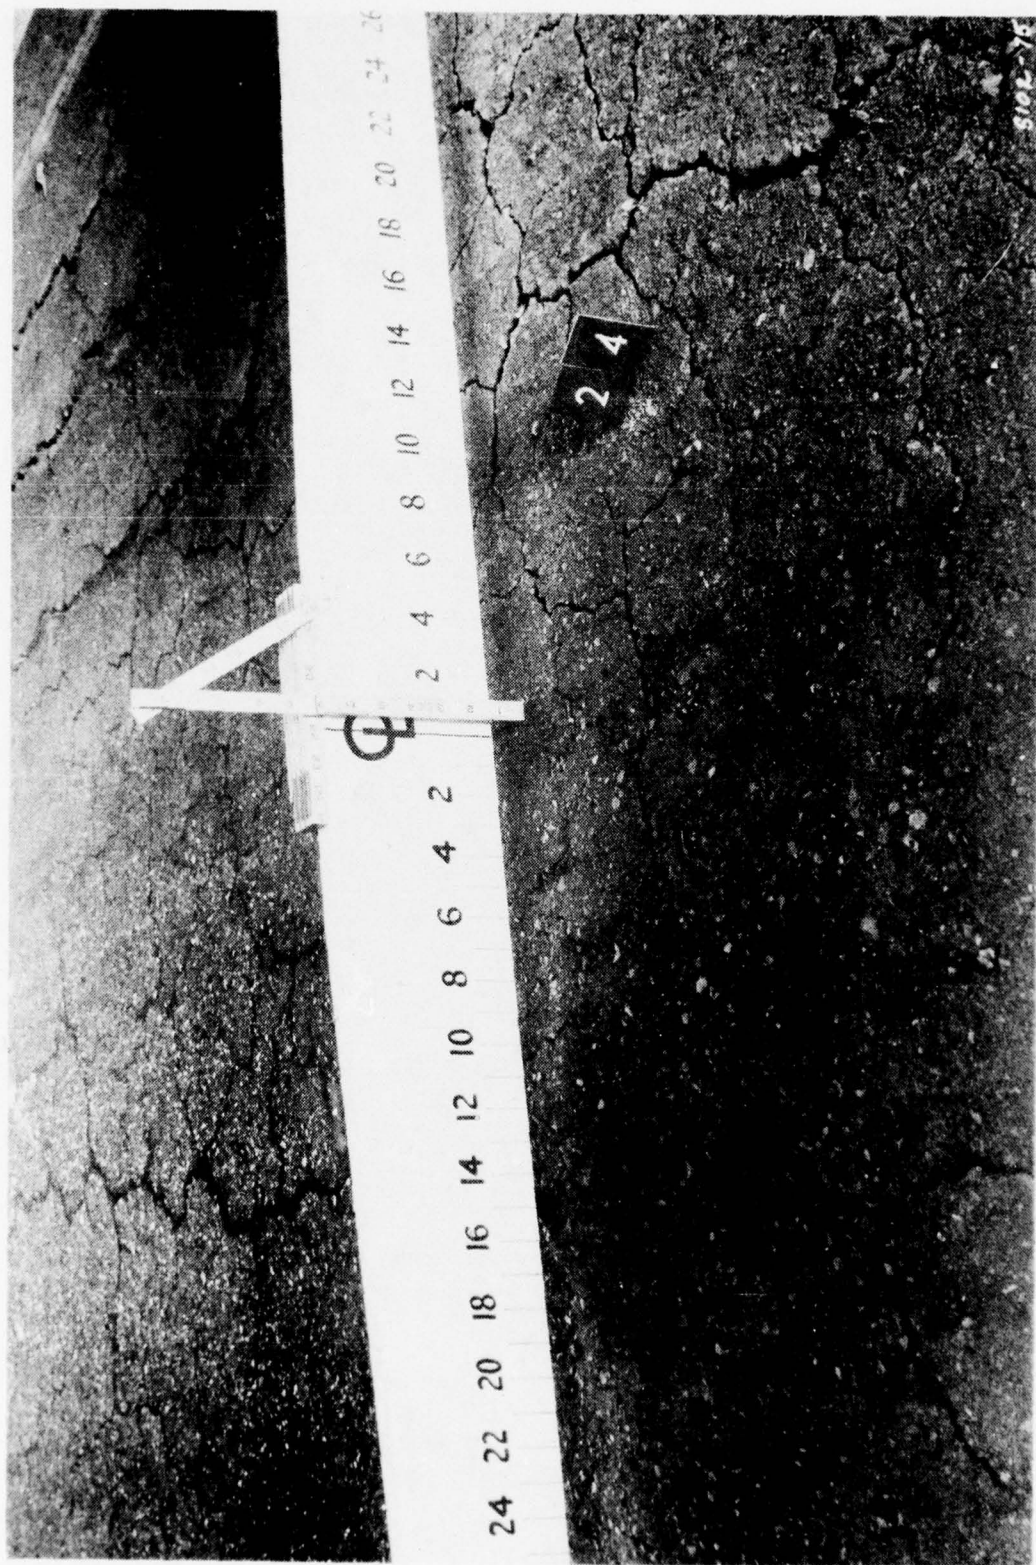
Figure 35. Deformation in Traffic Lane, Item 2, After 400 Coverages

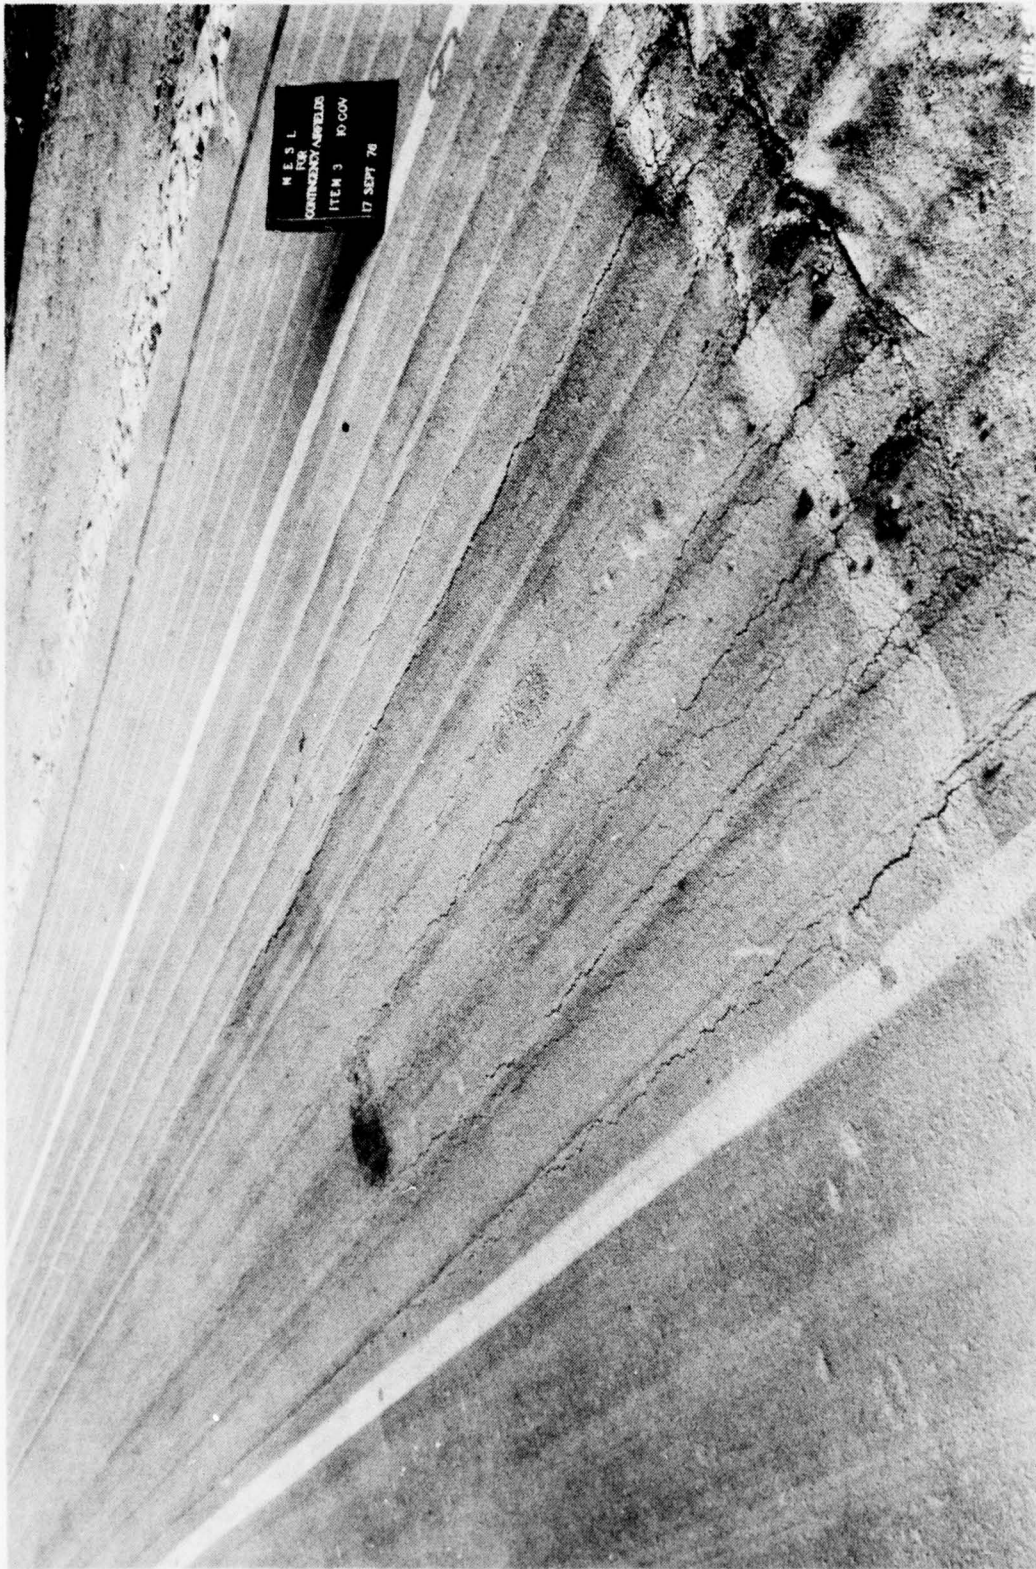
Figure 36 shows item 3 prior to traffic. Typical cross sections taken at 0, 10, and 25 coverages are shown in Figure 27. Hairline cracks were noted at two coverages and continued to develop with traffic and at 10 coverages were severe, as shown in Figure 37. Deformation at the centerline varied up to about 1.5 inches as shown in Figure 38. Traffic was continued to 14 coverages, then water was applied to the item. Lean clay was observed pumping through cracks in isolated areas; therefore, cracks had penetrated into the

Figure 37. Item 3 After 10 Coverages

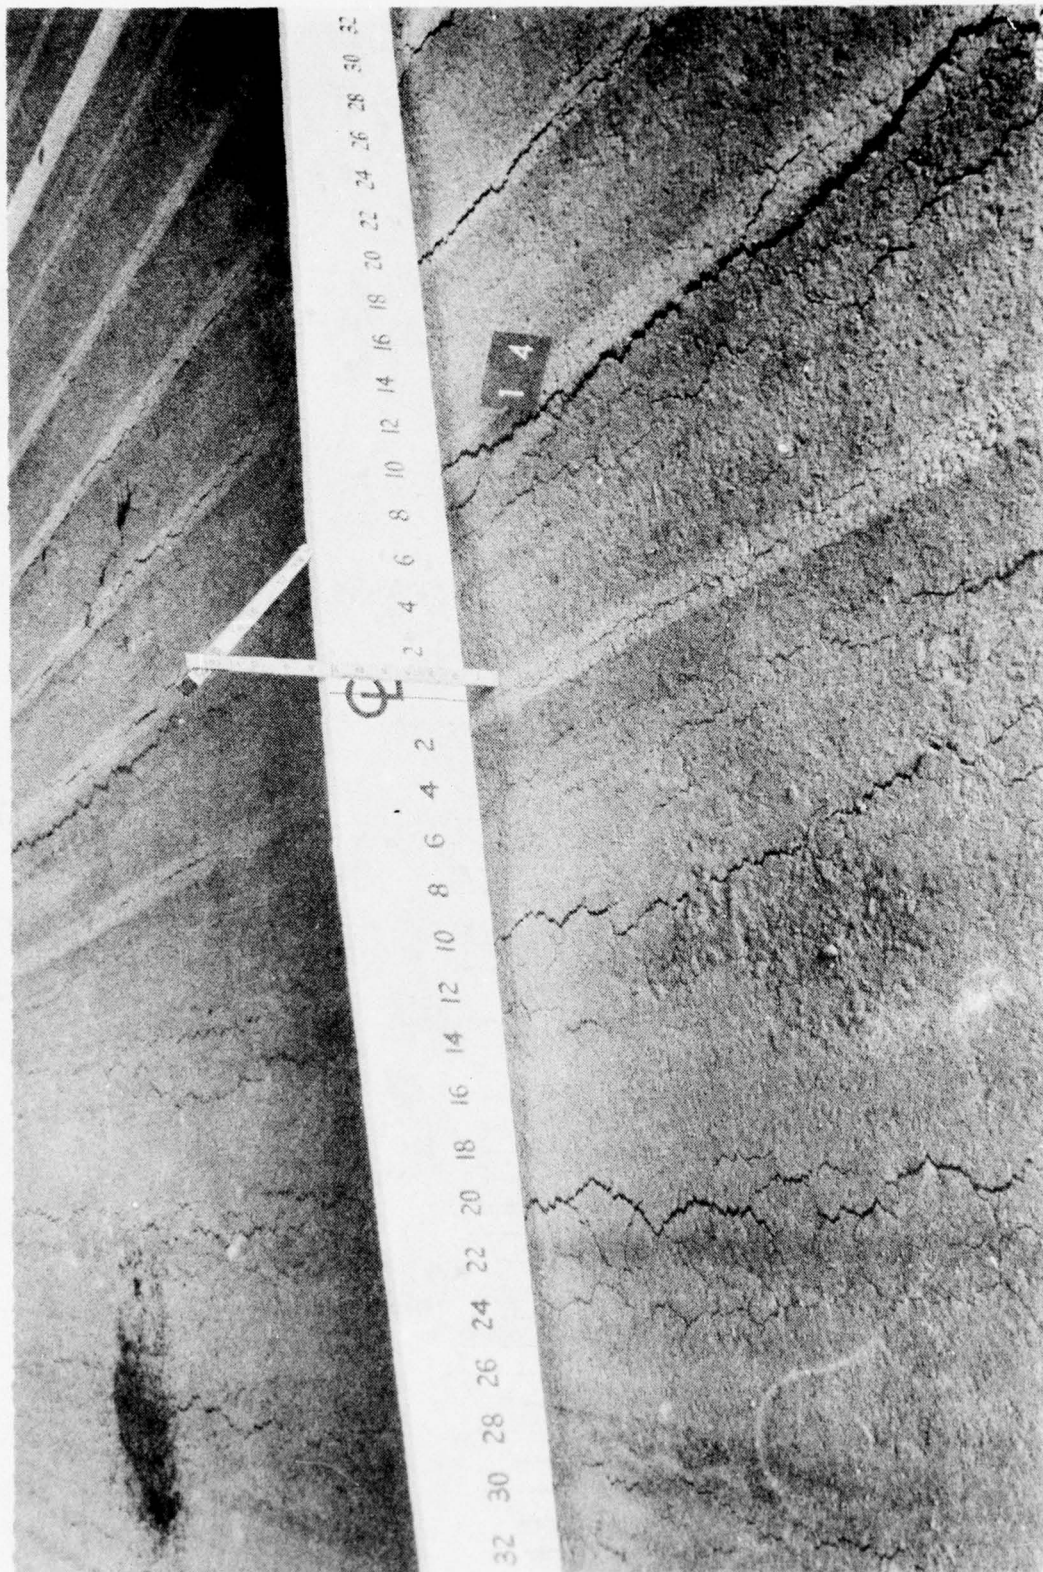
Figure 38. Deformation in Traffic Lane, Item 3, After 10 Coverages

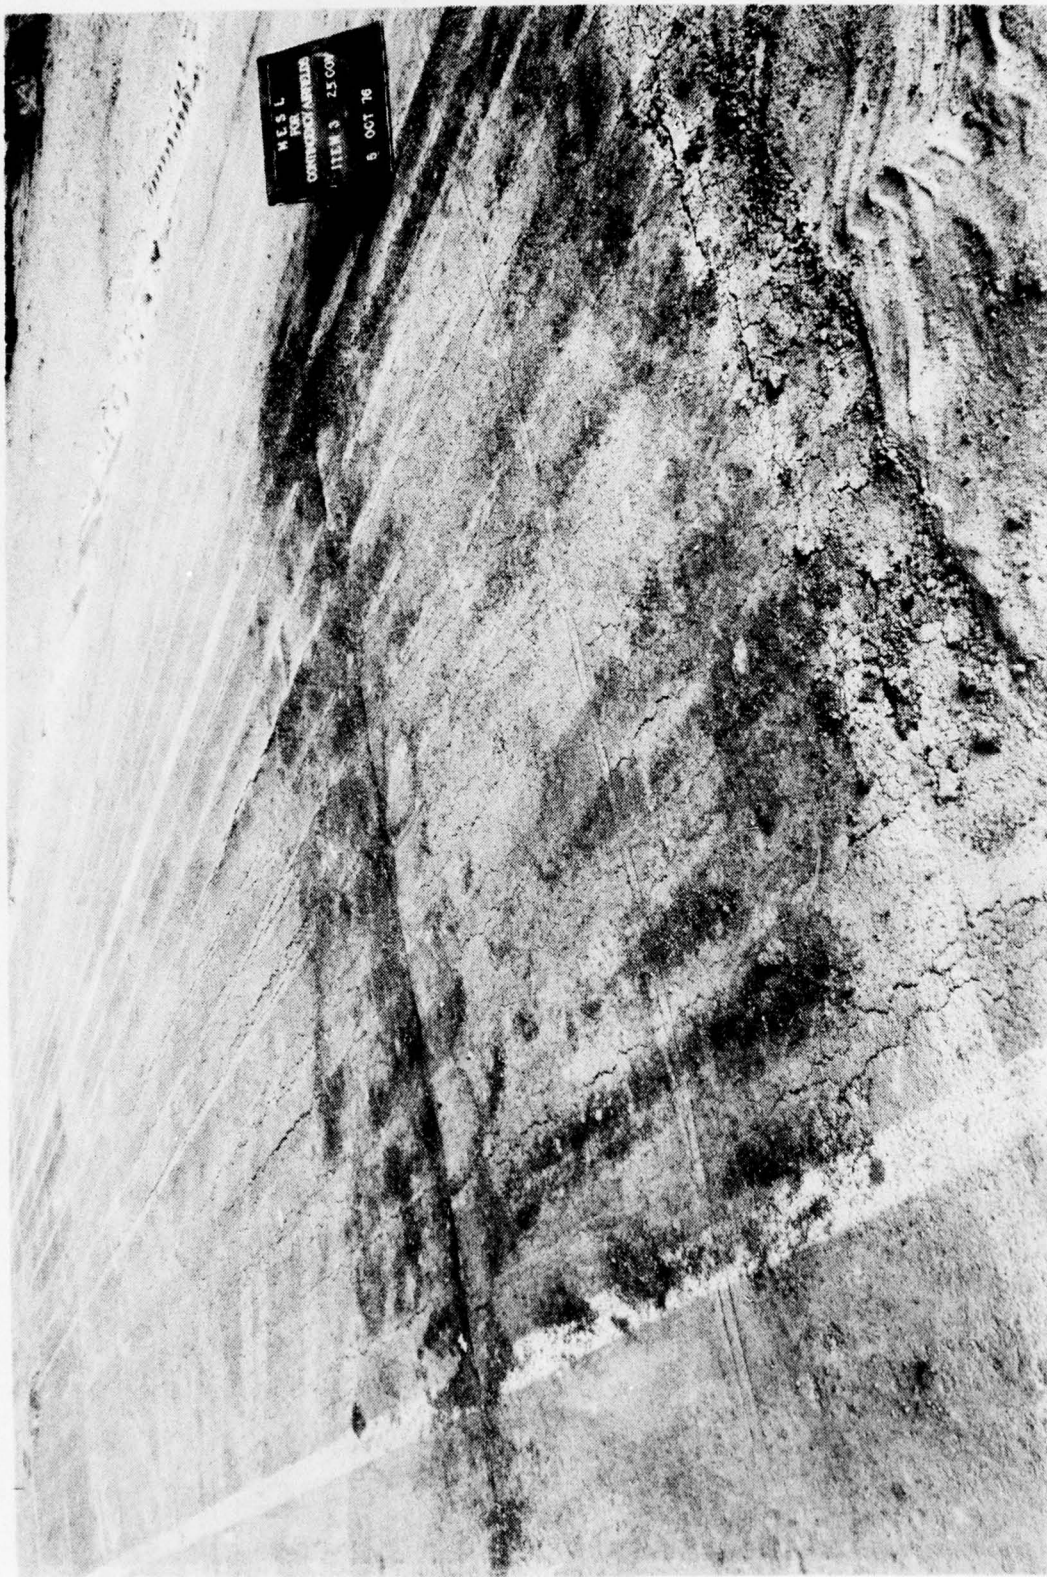
MESL. The item was considered failed at 14 coverages, but traffic was continued to 25 coverages. Figure 39 shows the condition of item 3 at termination of traffic.

Figure 39. Item 3 After 25 Coverages

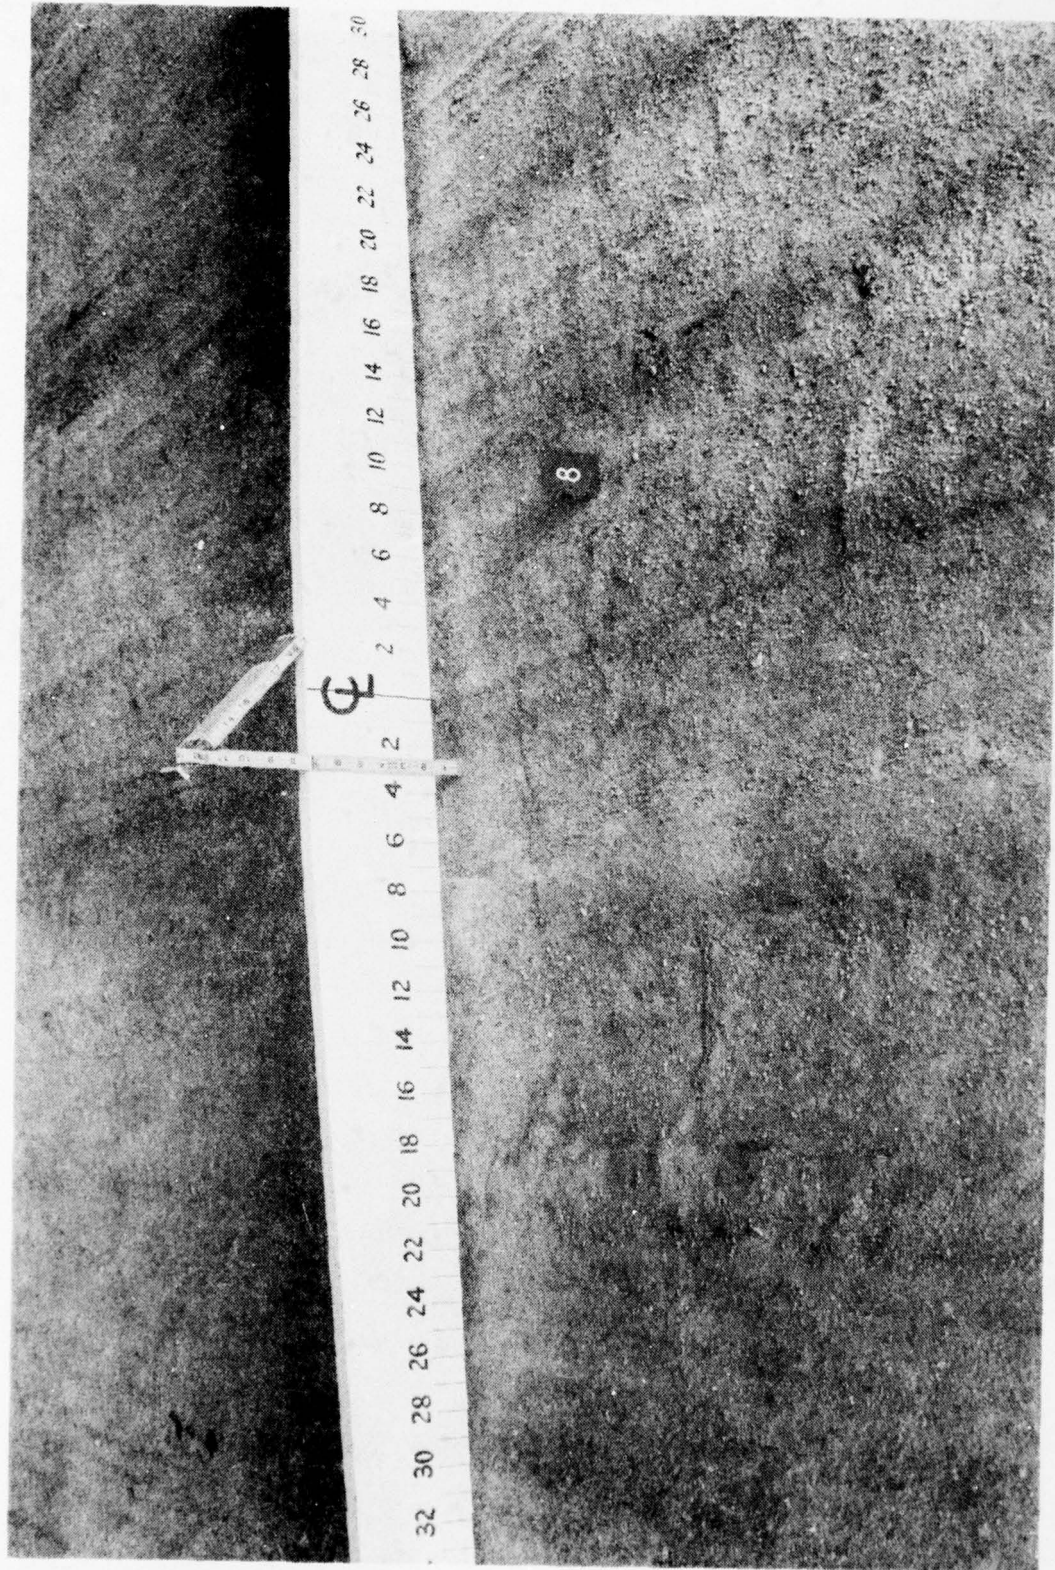
Figure 40 shows item 4 prior to traffic. Typical cross sections taken at 0, 10, and 14 coverages are shown in Figure 27. Slight wrinkling of the surface membrane and consolidation of approximately 1.5 inches, as shown in Figure 41, were noted on one-third of the item nearest to item 3 at two coverages. At six coverages wrinkling progressed to the point that it appeared to be no longer waterproof. Traffic was continued, and at 10 coverages deformation of about 3.5 inches was measured as shown in Figure 42. Wrinkling of the surfacing material was more pronounced, and the item was considered failed. Figure 43 shows the overall condition of the surface at 10 coverages. To verify that the surface was no longer waterproof, water was applied to part of the surface, and four more coverages of traffic were applied. During these coverages, it was evident from rutting that the lean clay had become wet and lost strength so traffic was terminated at 14 coverages.

Figure 41. Deformation in Traffic Lane, Item 4, After 2 Coverages

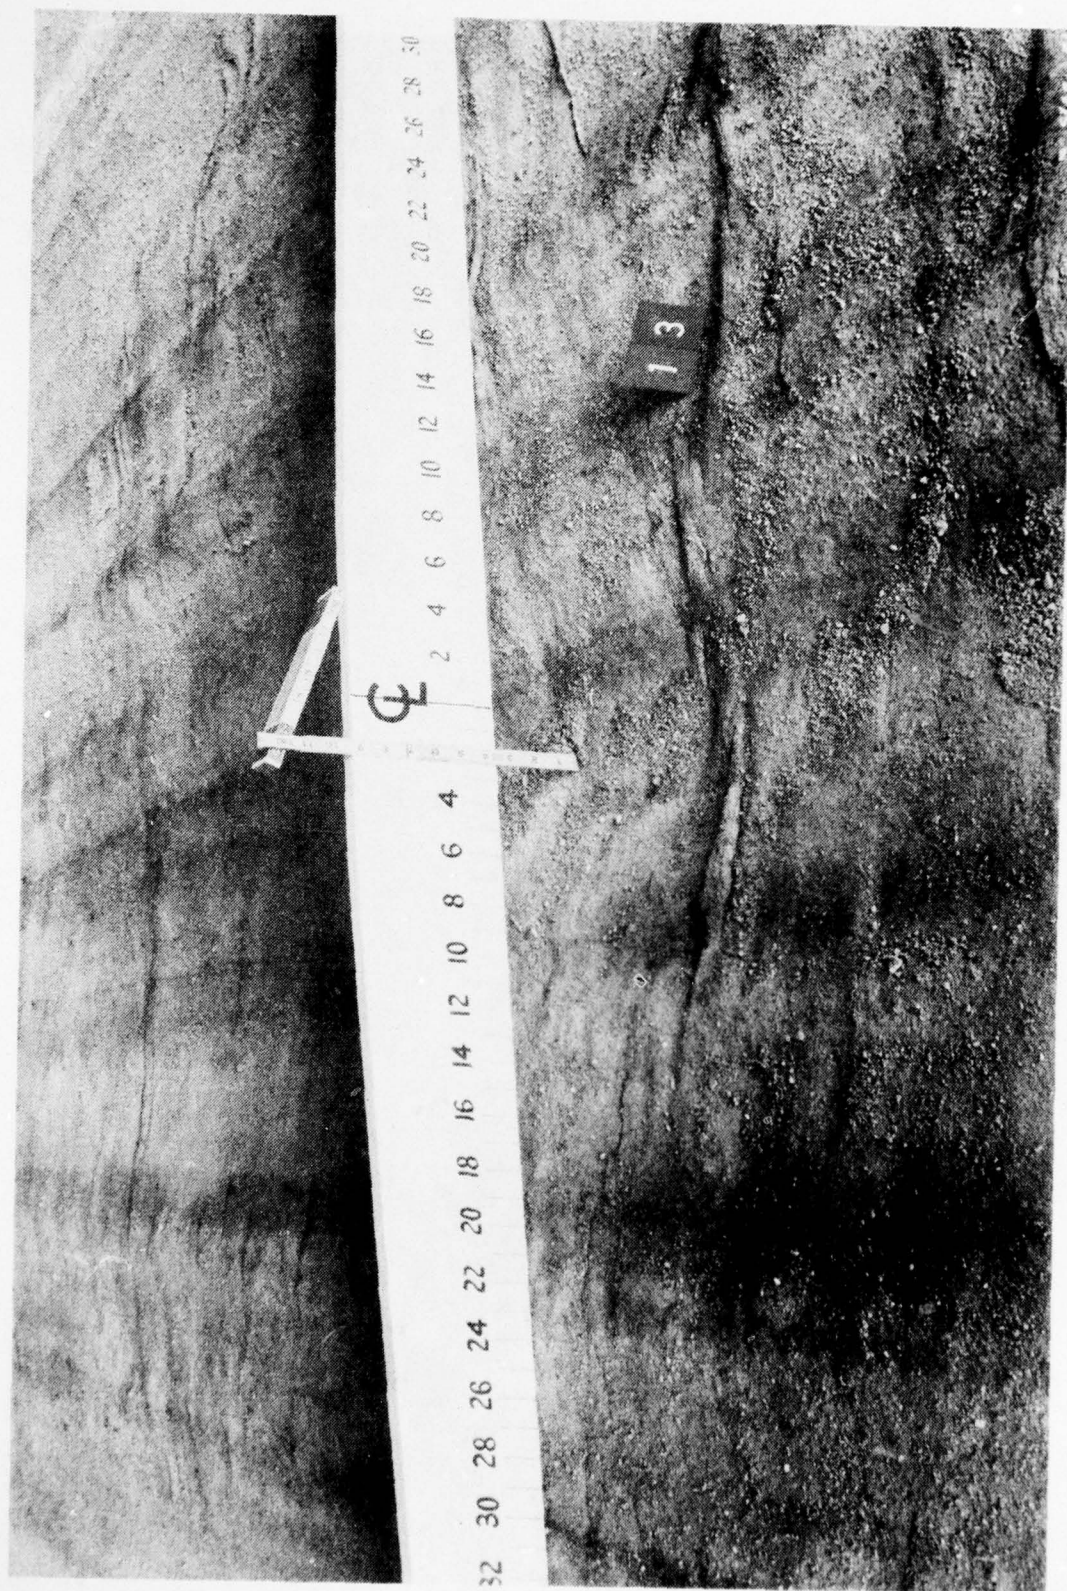
Figure 42. Deformation in Traffic Lane, Item 4, After 10 Coverages

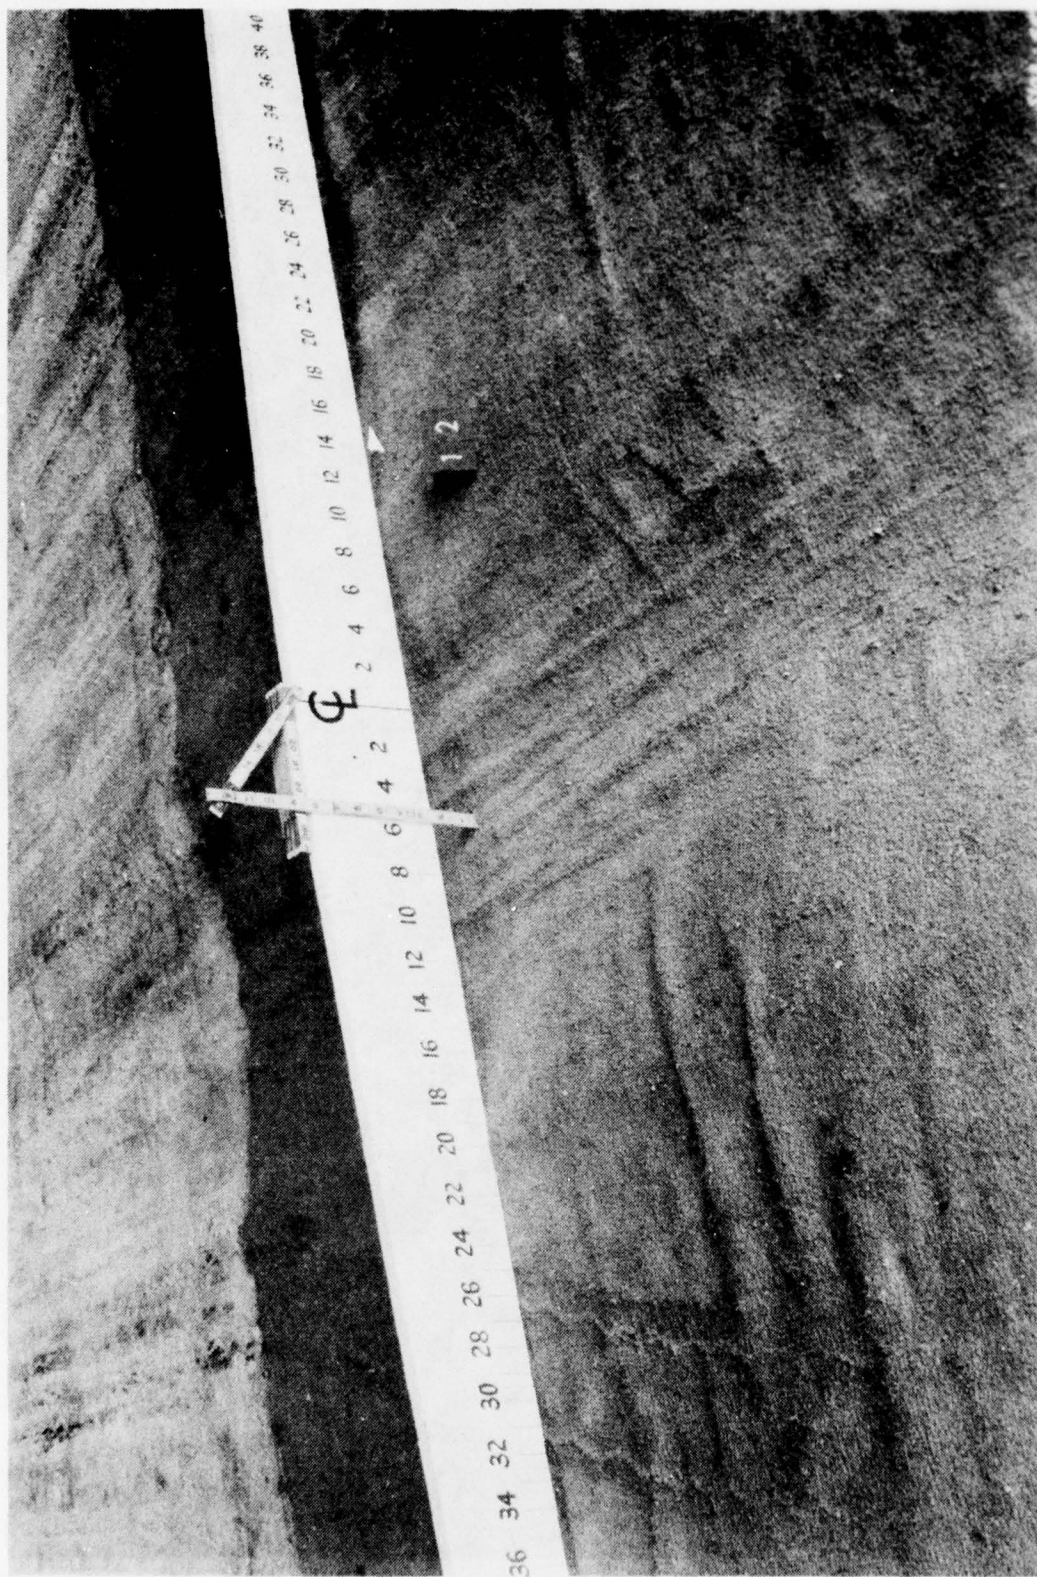
Figure 44 shows item 4A prior to traffic. Typical cross sections are shown in Figure 27. The half of the item located adjacent to the sod section, item 5, was affected by water migrating into the MESL from item 5. Wrinkling of the surface of the artificial turf occurred under traffic, and the material pulled loose from the surface of the MESL causing it not to conform to permanent deformation in ruts. No tears or other damage were noted in the material under traffic. After 10 coverages of traffic, permanent deformation of 2.5 inches, as shown in Figure 45, was measured. Traffic was terminated after 10 coverages, and the item considered failed due to the material tearing loose from the MESL surface and rut depth approaching depth required for failure. Figure 46 shows the surface after 10 coverages.

Figure 45. Deformation in Traffic Lane, Item 4A, After 10 Coverages

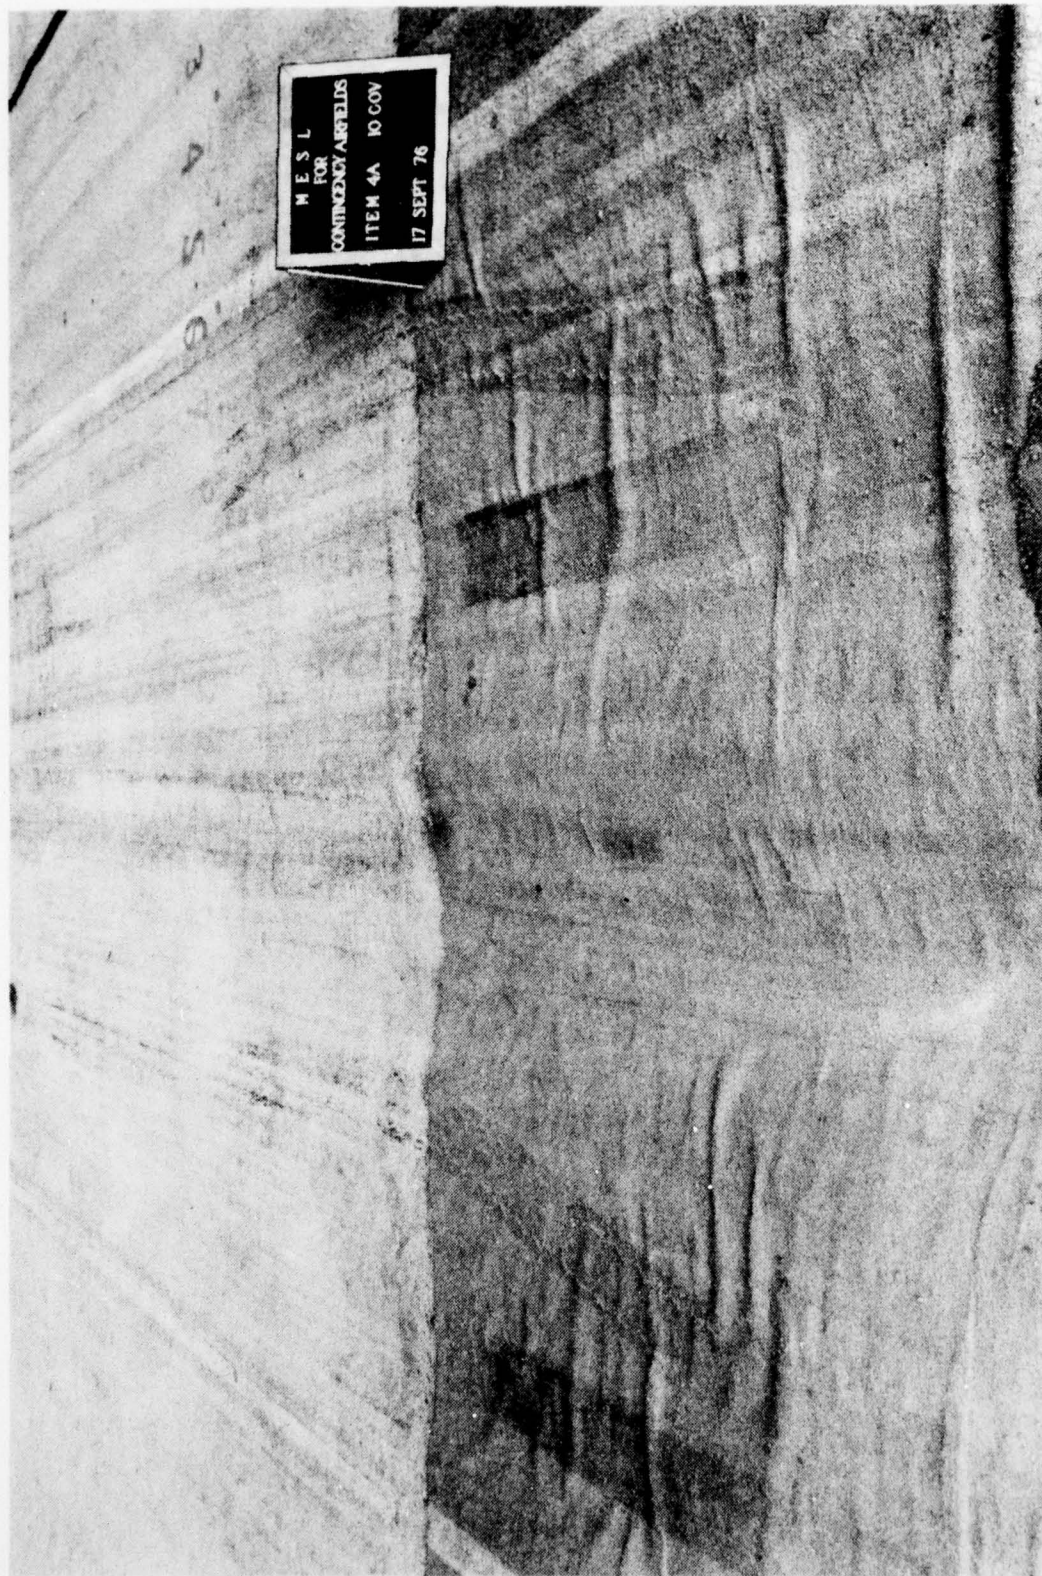
Figure 46. Item 4A After 10 Coverages

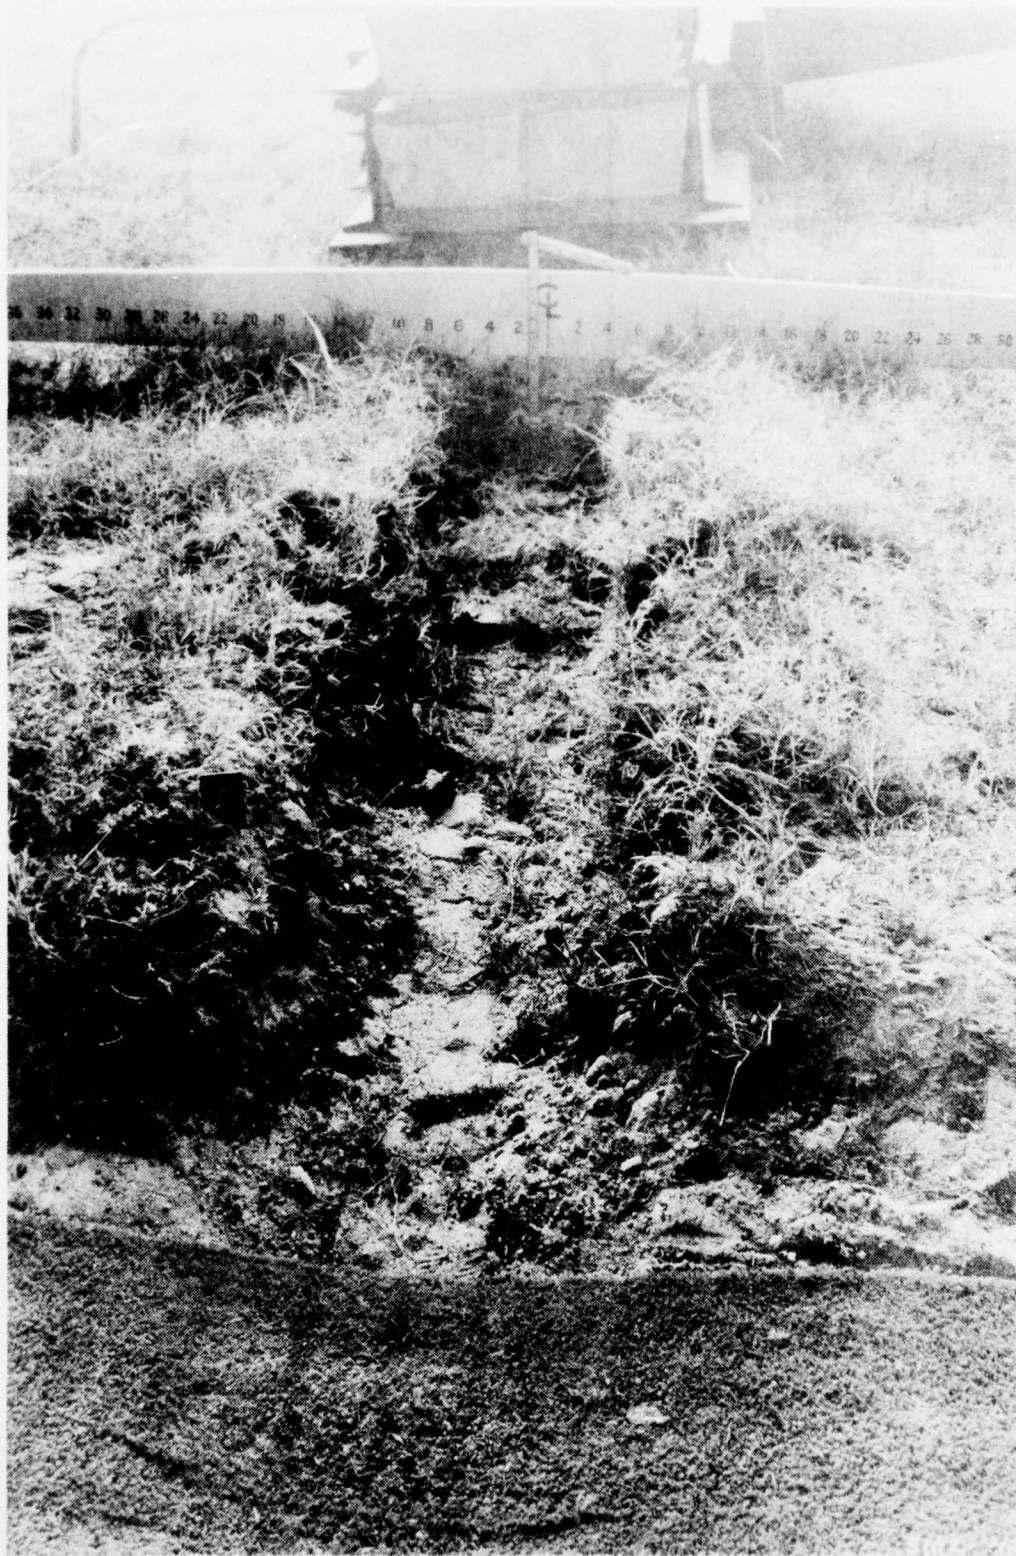
Figure 47 shows item 5 prior to traffic. The item failed on the first pass of the load cart during the rolling-wheel drawbar pull test. A rut depth of about 4 inches, as shown in Figure 48, developed as the load cart was towed onto the item. Moisture had penetrated through the surface of the MESL into the lean clay, causing a loss in strength of the MESL.

Figure 48. Rut in Item 5 After One Pass

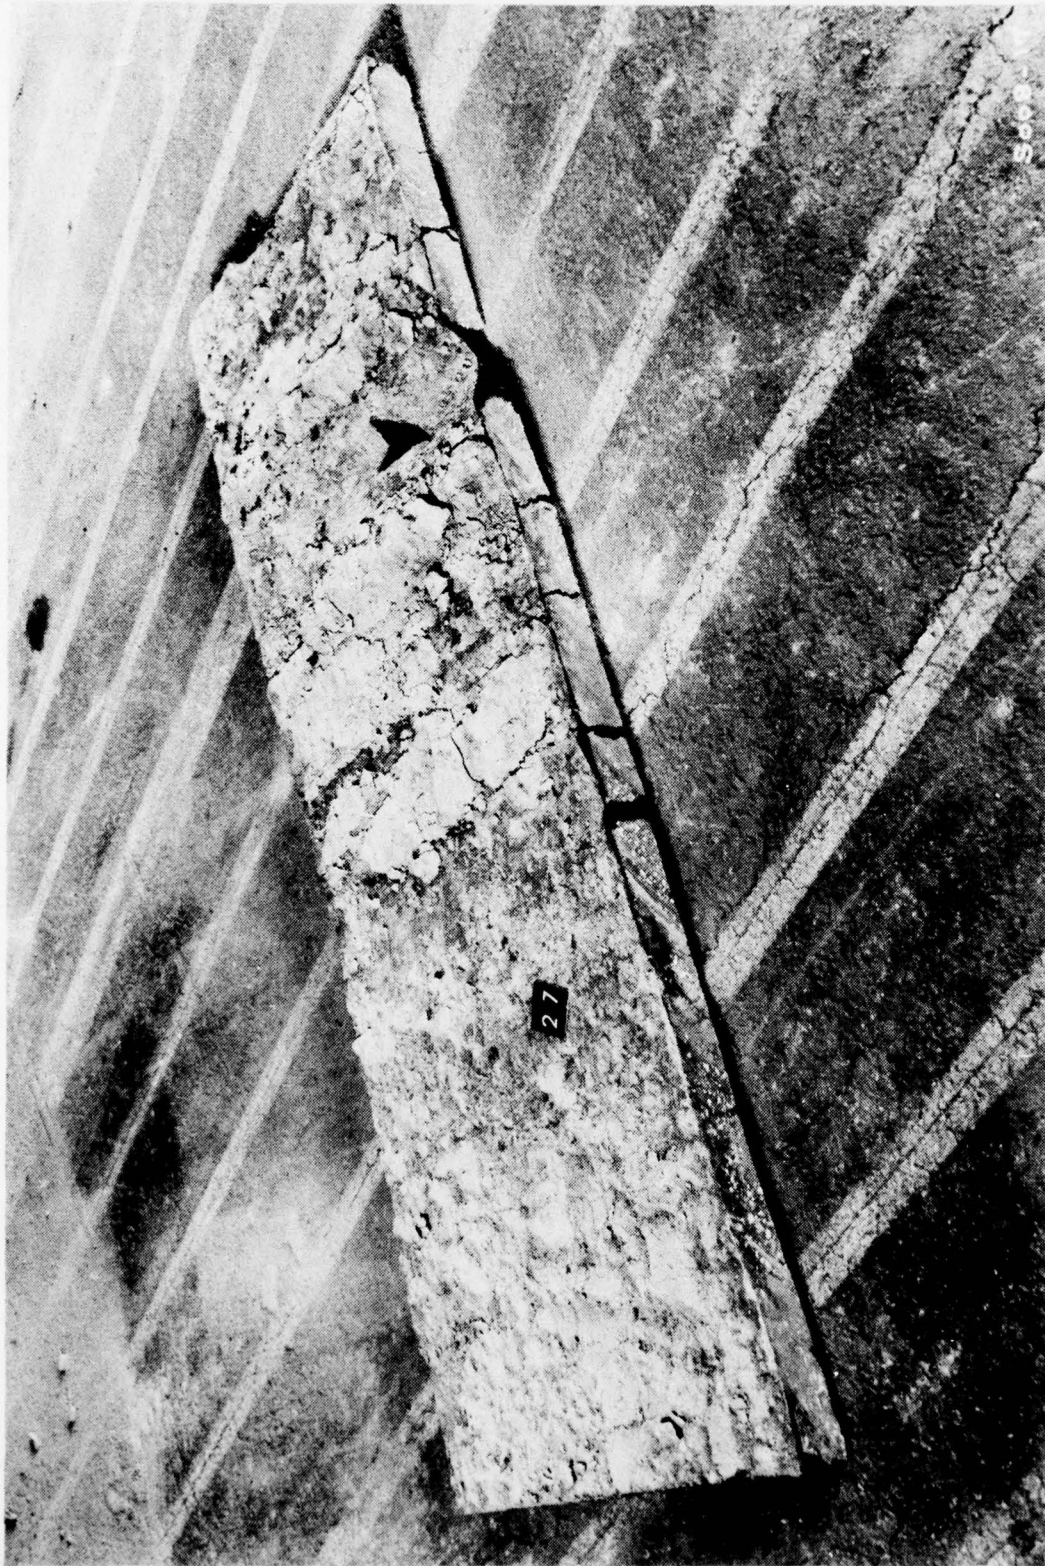
In-place tests on the subgrade show that the water content and density were about the same after traffic as during construction, but the CBR had increased from 7 to 9. Figure 52 shows the slab of asphaltic concrete removed from the test trench, cracks that developed the full depth of the pavement, and wet lean clay that adhered to the top membrane when asphaltic concrete was removed. Figure 53 shows that the polyethylene membrane at the bottom of the MESL was intact but began to fold at the edge of the traffic lane.

Figure 52. Wet Material That Adhered to Polypropylene Surface When Asphalt Concrete Slab Was Removed, Item 3
